DRAFT—Sellwood Bridge Existing Structural Deficiencies

The purpose of this memorandum is to summarize the structural deficiencies of Sellwood Bridge and provide assumptions for cost estimates to compare rehabilitation and replacement options. The structural deficiencies, in combination with geometric, safety, and operational deficiencies, will form the basis for the project's purpose and need statement.

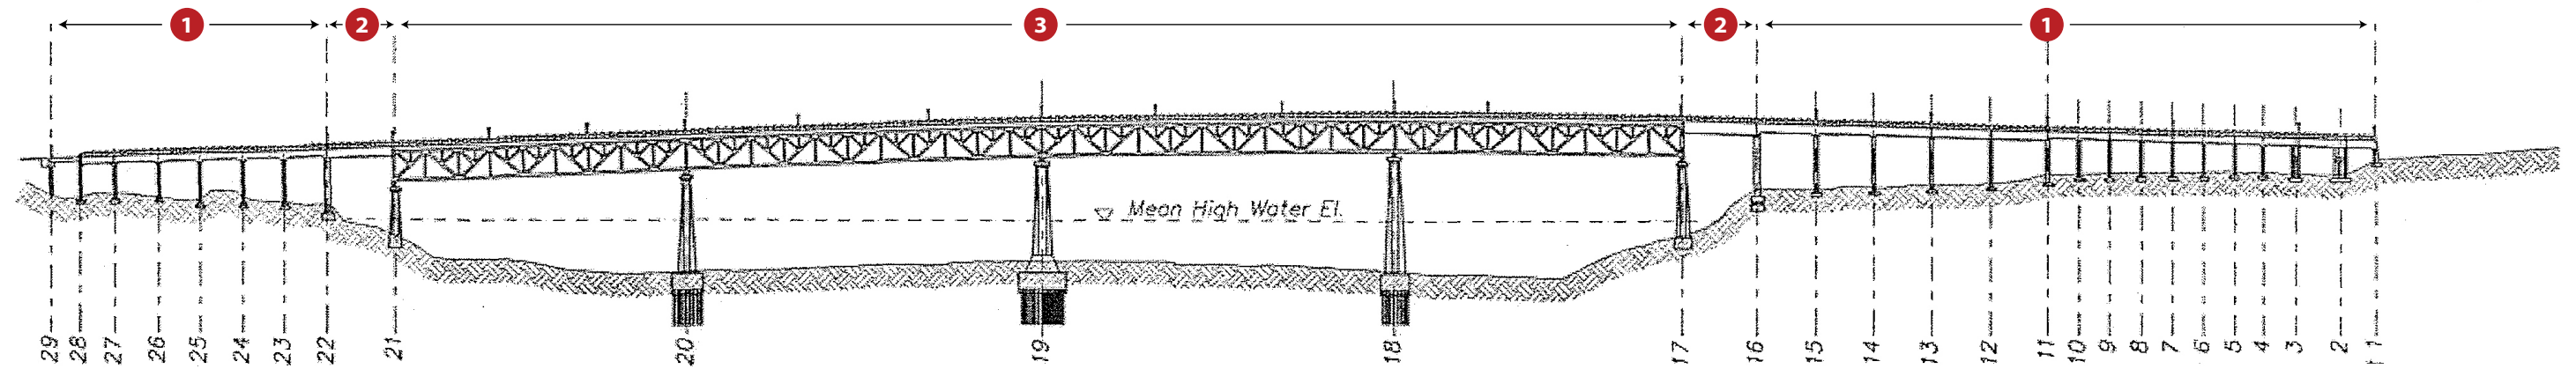
FIGURE 1
Sellwood Bridge Structural Deficiencies

| 294 feet long (Spans 21-29) | 1,092 feet long (Spans 17-20) | 586 feet long (Spans 1-16) |
| WEST APPROACH SPANS | MAIN RIVER SPANS | EAST APPROACH SPANS |
| <ul style="list-style-type: none"> • Cracks in concrete girders, deck and columns • Significant corrosion of steel girders • Girders are inadequate for 20-ton (H20) vehicles, TriMet buses • Potential damage to structure and possible collapse under major earthquake | <ul style="list-style-type: none"> • Cracks in concrete deck • Significant corrosion in steel stringers and floorbeams • Collision damage to bridge piers • Corrosion in steel truss • Potential damage to structure and possible collapse under major earthquake • Floorbeams are inadequate for 40-ton, 20-ton (H20) vehicles, TriMet buses | <ul style="list-style-type: none"> • Cracks in concrete, girders, decks and columns • Significant corrosion of steel girders • Potential damage to structure and possible collapse under major earthquake • Girders are inadequate for 20-ton (H20) vehicles, TriMet buses |
| 10-Ton Load Limit | | |
