# DRAFT—Sellwood Bridge Existing Roadway Deficiencies

# Background Report

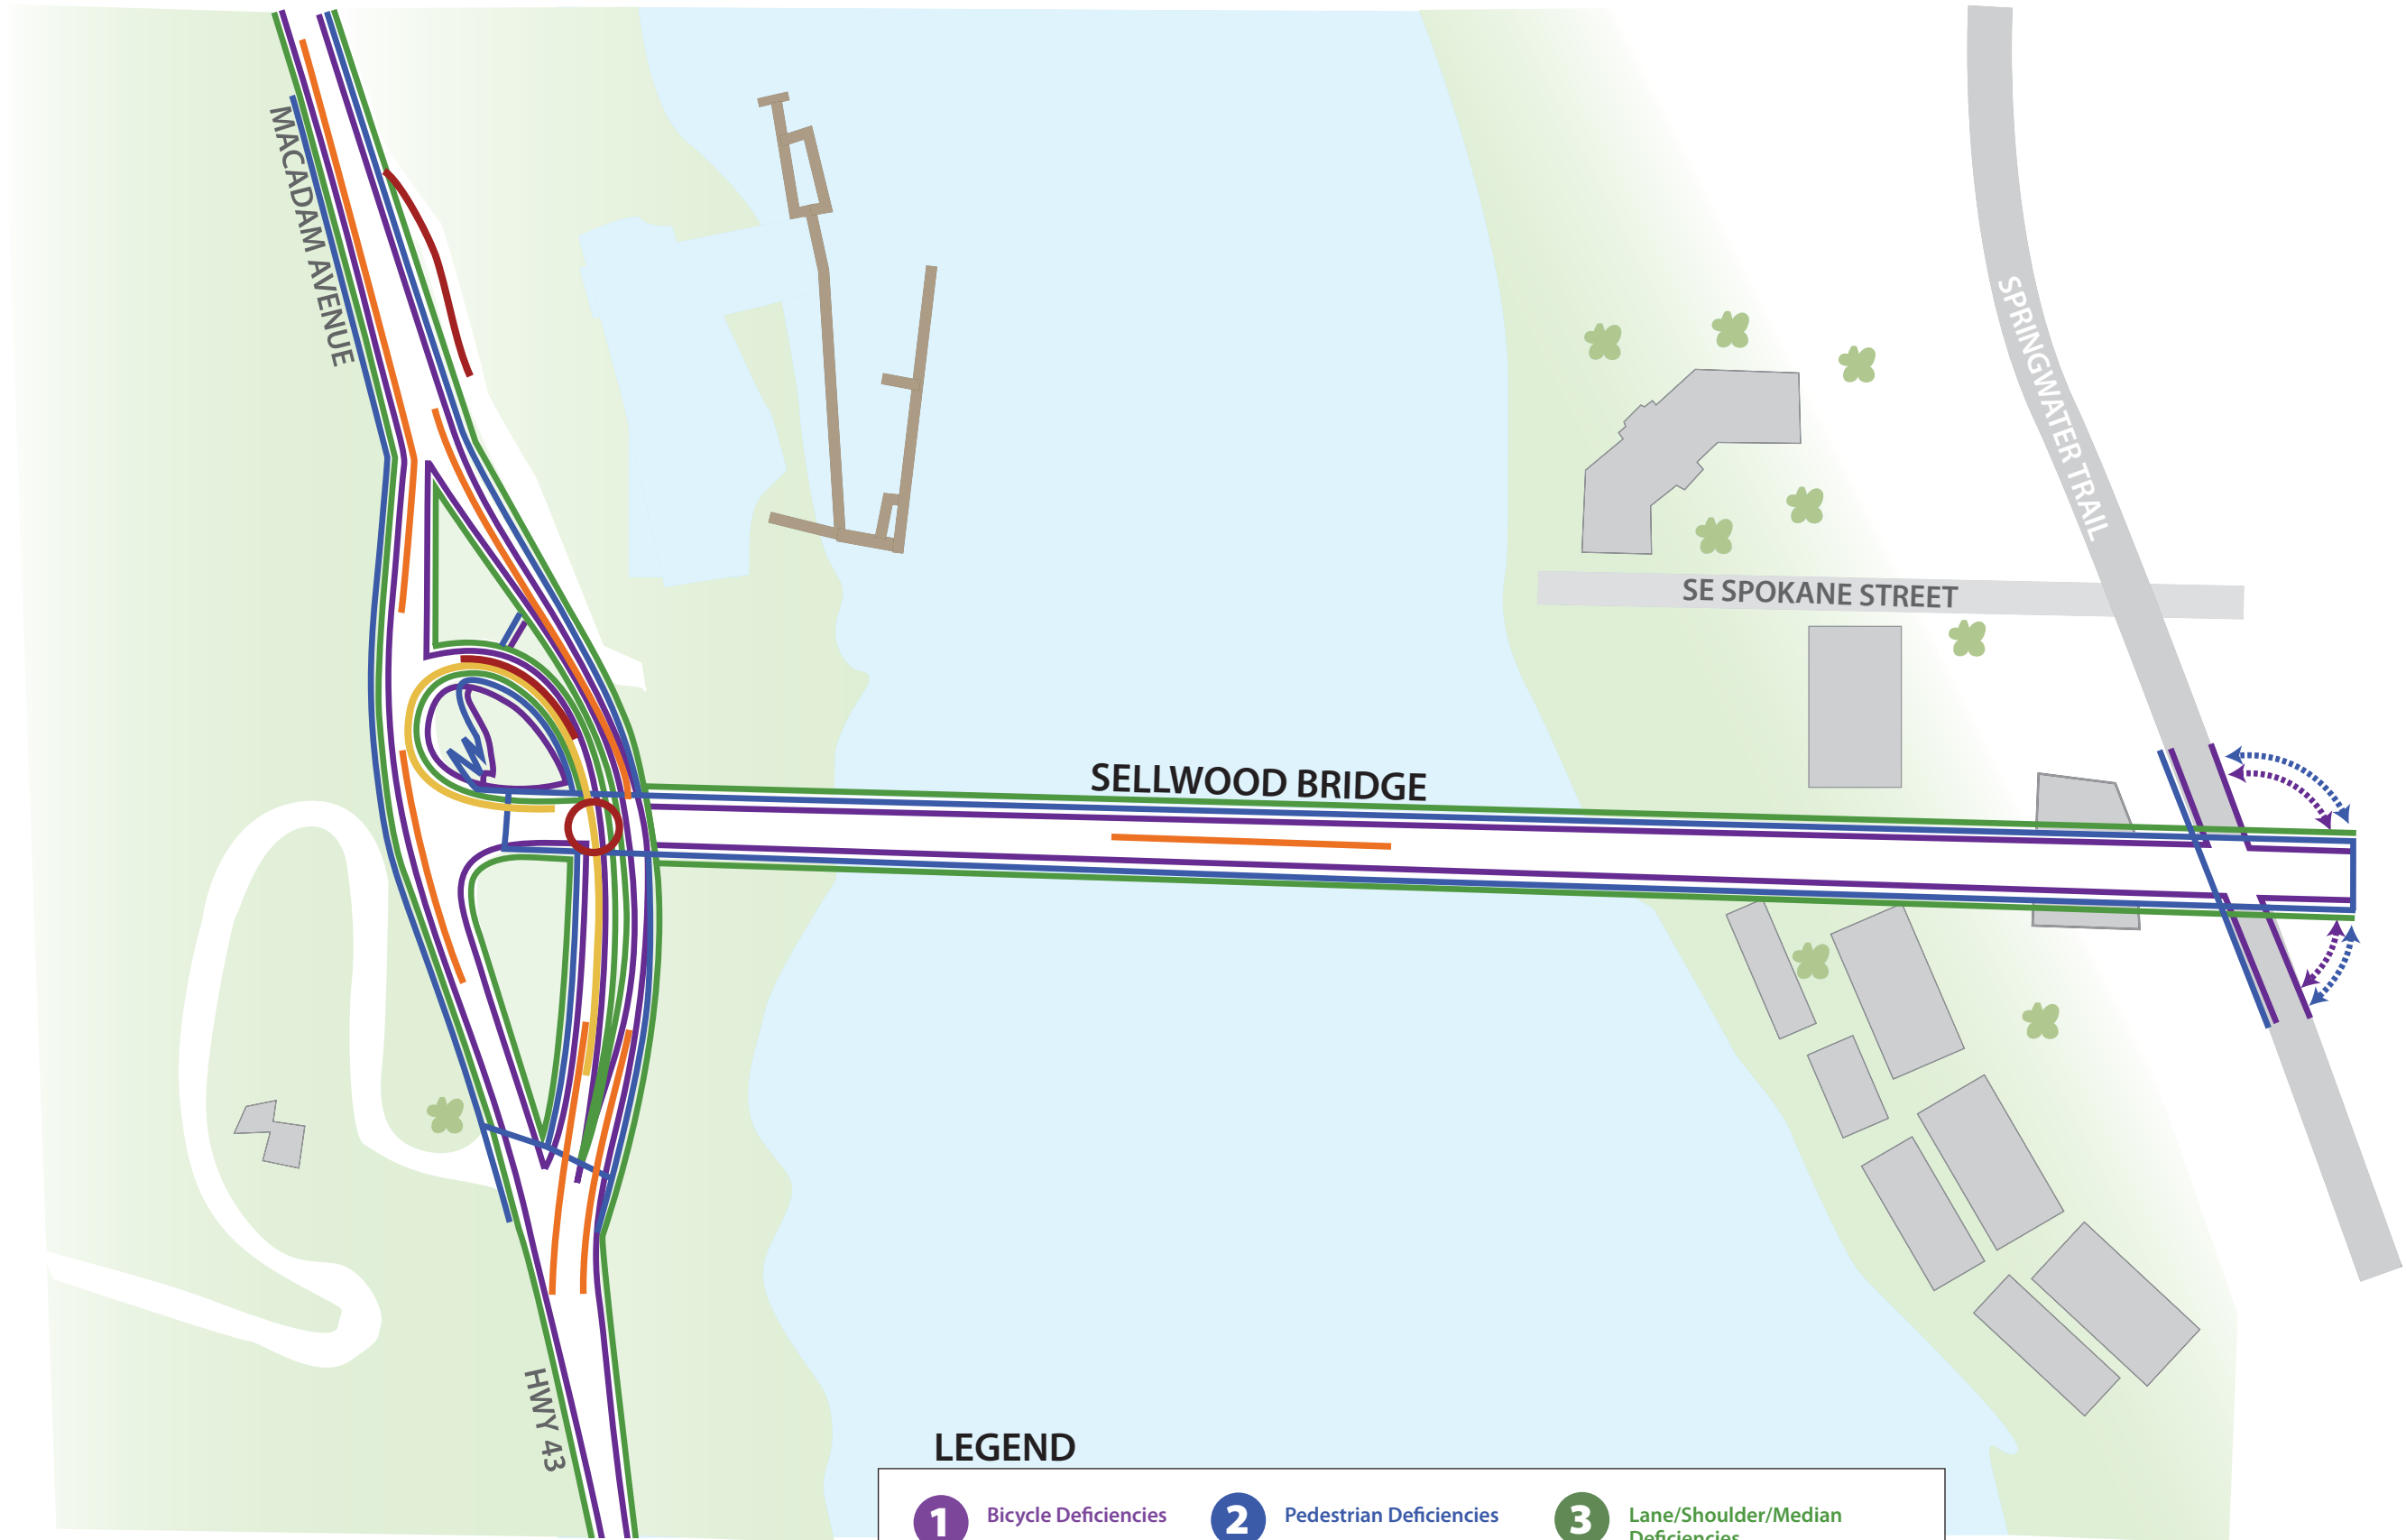
- Lane, Shoulder, and Median Widths**—There are narrow travel lanes and narrow or nonexistent shoulders and medians throughout the study area. These deficiencies increase the potential for collisions between vehicles. Lane and median widths have an impact on driver comfort, safety, and crash potential. There is no shoulder area to accommodate emergency parking, disabled vehicles, and emergency response vehicles.

- **Horizontal Curvature (Segment 3)**—The radius of the southbound loop ramp curve (Segment 3) is substantially tighter than what is allowed under the state standard. This has led to a restriction in the size of vehicle that can use the loop ramp. Horizontal curves that are too tight also lower vehicle speeds, lower capacity, and decrease sight distance.

| <b>1</b> Bicycle Deficiencies | <b>2</b> Pedestrian Deficiencies | <b>3</b> Lane/Shoulder/Median Deficiencies |
| <b>4</b> Horizontal Curvature Deficiency | <b>5</b> Horizontal and Vertical Stopping Sight Distance Deficiencies | <b>6</b> Miscellaneous Deficiencies (Access Spacing Deficiencies, Grade Deficiencies, and Vertical Clearance Deficiencies) |

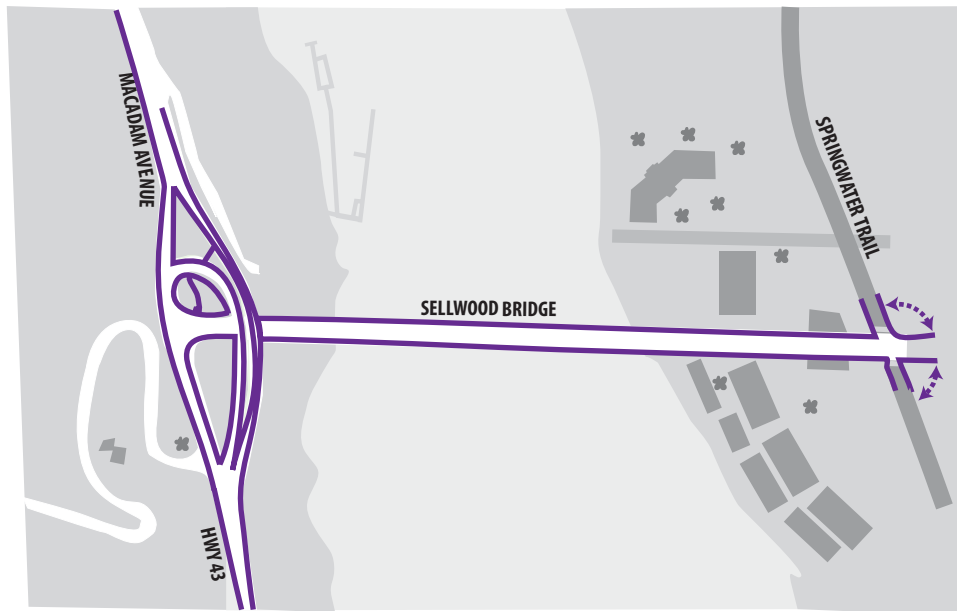
**1** Bicycle Deficiencies

- Bicycle and Pedestrian Facilities**—There are no bicycle lanes and narrow or nonexistent sidewalks on both the Sellwood Bridge and on Highway 43, Macadam Avenue. Bicycle and pedestrians are forced to share common space, which is too narrow to be shared safely. This lack of adequate bicycle and pedestrian facilities creates a safety concern and is a barrier between elements of the local and regional bicycle and pedestrian network. Furthermore, bicycle lanes, sidewalks, crosswalks, and access routes throughout the study area are not compliant with the Americans with Disabilities Act (ADA).

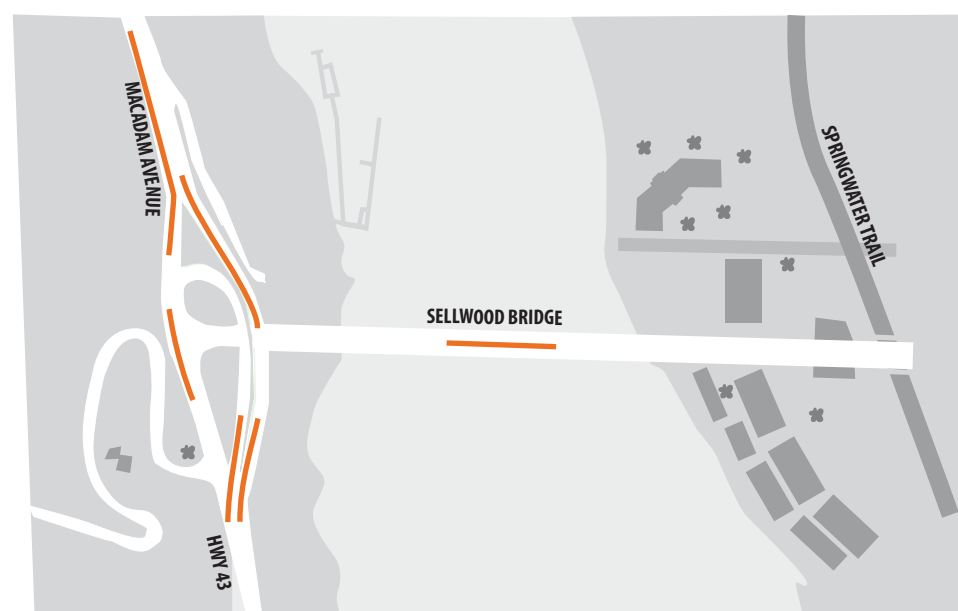
**5** Horizontal and Vertical Stopping Sight Distance Deficiencies

- Stopping Sight Distance**—There are segments of Highway 43, Macadam Avenue where safe stopping sight distance is not provided due to the horizontal or vertical curvature of the roadway. Adequate stopping sight distance (the distance for a vehicle traveling at normal speeds to stop) is needed to give drivers enough time to safely stop their vehicles once a road obstruction has become visible. Obstacles such as retaining walls and steep hillsides block the line of sight around corners when they are located too close to the travel lane. If the “hump” of a vertical curve is too extreme, it will block the line of sight to the other side of the hill.

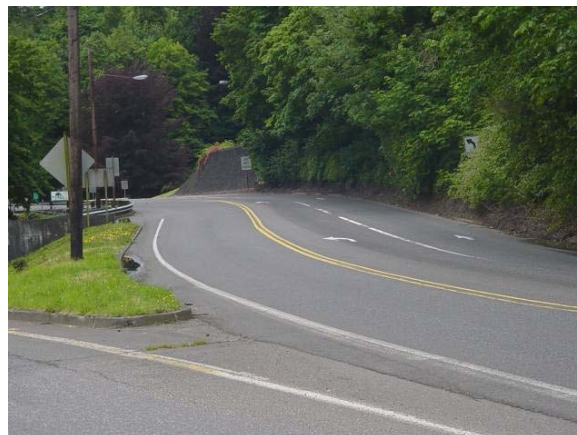
Figure 4: View of southbound left-turn lane from Highway 43 onto Sellwood Bridge.

- **Lane and Shoulder Width**—As shown in Table 2 below, the two travel lanes meet ODOT standards. The southbound left turn lane is 1 foot more narrow than the standard. No shoulders exist.

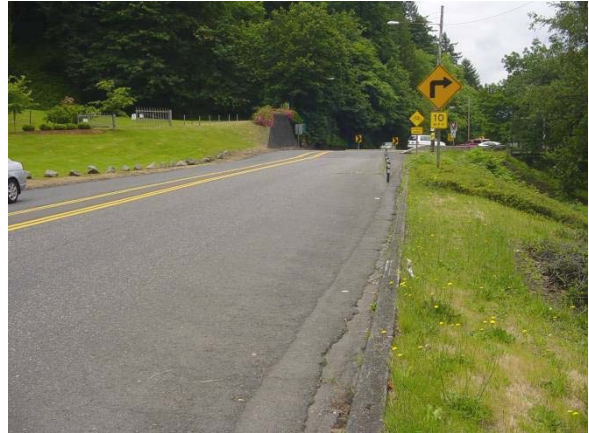
Figure 5: No sidewalks, crosswalks, or bicycle lanes exist on the mainline of Highway 43 in the vicinity of the Sellwood Bridge.

The ODOT HDM requires sidewalks at least 6 feet wide with 6-foot-wide landscape buffers. In physically constrained locations, 8-foot-wide sidewalks could be constructed in lieu of a buffer. The HDM also requires 8-foot-wide shoulders on 4-lane highways with ADT greater than 28,000 vehicles. The shoulders may or may not be striped as a bicycle lane. A shoulder width of 6 feet is required on the 2-lane access ramp between the Sellwood Bridge and River View Cemetery entrance. The Oregon Bicycle and Pedestrian Plan also recommends that bicycle lanes and sidewalks be at least 6 feet wide.

Bicycle travel between Highway 43 and the Sellwood Bridge is problematic in several locations. Unless they walk their bicycles along the adjacent narrow multi-use path, cyclists traveling from the Sellwood Bridge to Highway 43 northbound conflict with motorists turning onto Southbound Loop Ramp. Cyclists then must cross the Northbound Bypass Ramp where it merges with Highway 43 in order to maneuver to the right side of the road.

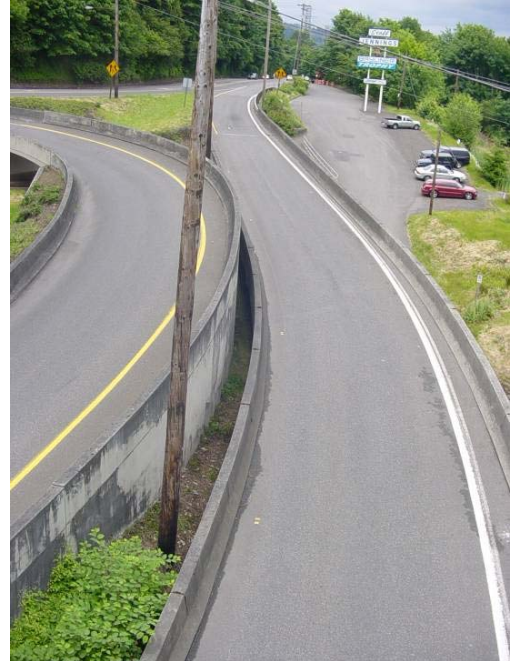
- **Stopping Sight Distance**—The stopping sight distance for the northbound bypass is approximately 200 feet. It should be a minimum of 305 feet. The line of sight is blocked by the retaining walls supporting the loop ramp.

Figure 6: Northbound bypass ramp (to the right) as seen from the Sellwood Bridge.

- **Bicycle or Pedestrian Facilities** – There are no sidewalks or bicycle lanes on the Northbound Bypass Ramp. The right-side shoulder (where bicycle travel would normally occur) is currently 2 feet wide. The HDM requires a right shoulder width of 6 feet (8 feet when directly adjacent to a barrier or guard rail).
- **Lane and Shoulder Width** – As shown in Table 3 below, the ramp travel lane and left shoulder meets current standard. The ramp right shoulder does not meet standard.

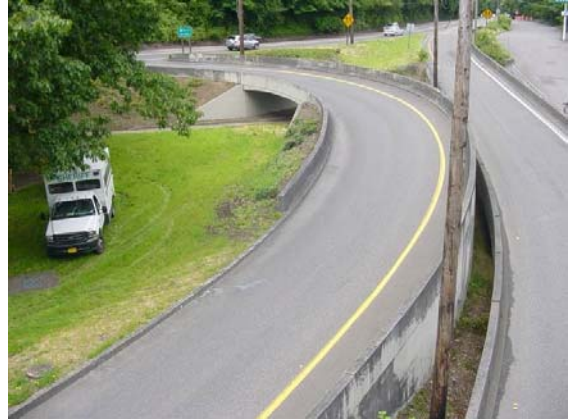
The southbound loop ramp, as illustrated in Figure 7, is a one-way, one-lane ramp to connect vehicles coming from the Sellwood Bridge with Macadam Avenue southbound (traveling toward Lake Oswego). The ramp splits off to the right from Highway 43 and loops under the Sellwood Bridge structure immediately west of the northbound bypass ramp. The ramp reconnects with Highway 43 at the same location that the northbound bypass ramp begins. There is a traffic signal at this location to help facilitate vehicle movement.

Figure 7: Southbound loop ramp (to left) as seen from Sellwood Bridge.

- **Horizontal Alignment**—The loop ramp is composed of three consecutive horizontal curves. The loop curve radii, beginning at the end of the Sellwood Bridge, are 87 feet, 57 feet, and 181 feet. No one curve should be less than 159 feet. Consequently, the posted speed is less than the design speed standard for ramps. Additionally, because of the tightness of the loop, the largest vehicle that can safely travel the loop is an intermediate semi-trailer (designated as a “WB-40” vehicle). WB-40 vehicles typically have characteristics similar to a fire truck.
- **Vertical Alignment**—The profile of the southbound loop ramp has a series of deficient vertical curves. The length of the first vertical crest curve is 120 feet. Based on existing grade, it should be at least 140 feet. The length of the middle vertical sag curve is 250 feet. Based on

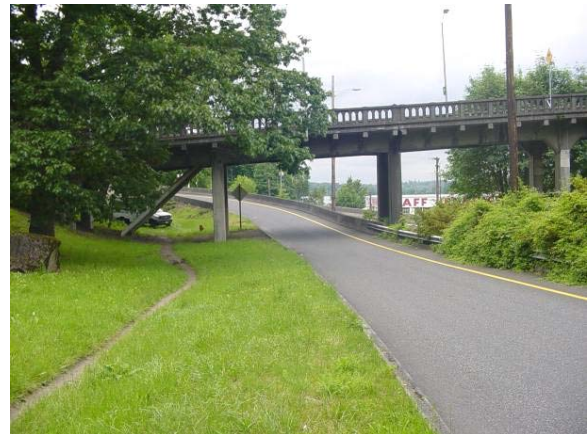
Figure 8: Worn pedestrian path along west side of southbound loop ramp.

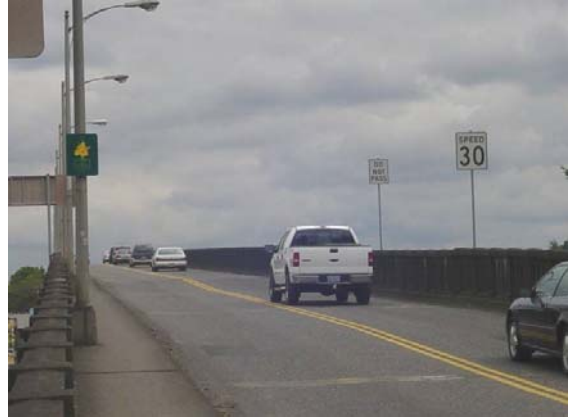
The Sellwood Bridge, shown in Figure 9, is a four-span continuous deck truss bridge that connects Highway 43 on the west with SR 99E on the east via SE Tacoma Street. It is owned and maintained by Multnomah County, and is classified by the City of Portland as a District Collector. With an ADT of approximately 35,000 vehicles/day, the Sellwood Bridge is the busiest two-lane bridge in the State of Oregon. The Sellwood Bridge opened in 1925 as the first fixed span bridge along the Willamette River in Portland. The Bridge has no on-street bicycle facilities and a 4-foot sidewalk on the north side.

Figure 9: Looking eastward onto the Sellwood Bridge.

- **Pedestrian Facilities**—The sidewalk on the bridge's north side is 4 feet 4 inches wide, with 3 feet of pedestrian space around light poles. There is no sidewalk on the south side. Sidewalks should be at least 6 feet wide on both sides of the bridge to meet minimum City standards for sidewalks. On the bridge's west end, there are no pedestrian connections between the bridge sidewalk and Highway 43 southbound. On the bridge's east end, there is no delineated crossing to connect pedestrians with the south side of Tacoma Street.

- **Bicycle Facilities**—There are no designated bicycle facilities on the Sellwood Bridge. Cyclists must either use vehicle travel lanes or walk their bikes on the narrow sidewalk. The BTA listed the Sellwood Bridge as “nearly uncrossable” and “the biggest barrier identified in the Portland area.” The crossing is listed by the BTA as one of the top 10 needed bicycle projects in the region. The Portland Bikeway Design and Engineering Guidelines generally recommend 5-foot-wide bicycle lanes. Six-foot-wide lanes are preferred on roadways with high posted speeds and/or high vehicle and bicycle volumes.

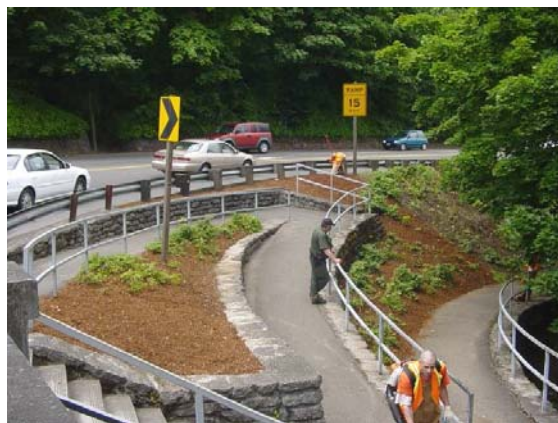
Figure 10: View of multi-use pathway, from Sellwood Bridge.

- **Pathway Width**—The southern half of the multi-use path (within the loop ramp) is 5 feet wide, and the northern half widens to 8 feet. The standard for multi-use paths in the City of Portland is 12 feet, with 3 feet of shy distance on each side. ADA requires a minimum access width of 5 feet. This can be reduced to 3 feet if 5-foot passing spaces are provided every 200 feet.
- **ADA**—The profile of the path does not meet ADA requirements. The path has segments with grades varying between 7.2 and 8.3 percent, with level landings separated by more than 30 feet. The ADA requires all pedestrian pathways to have a maximum grade of 5 percent. Grades can be increased to 8.3 percent, but require level landings every 30 feet.

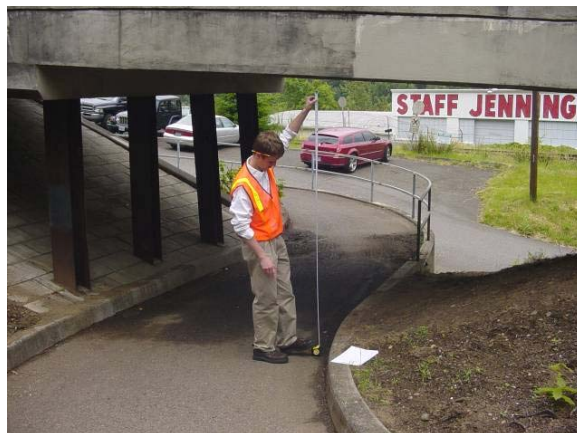
- **Horizontal Curvature**—The multi-use path is characterized by tight turns and limited sight distance. For multi-use paths, AASHTO recommends a minimum turning radius of 36 feet (assuming a bicyclist operating speed of 12 miles per hour with a 15 degree bicyclist “lean angle”). The path also does not meet AASHTO bicycle stopping sight distance standards due to the presence of multiple tight turns and relatively steep grades.
- **Signage**—The multi-use path lacks signage warning users of limited sight distance and tight turns.
- **Vertical Clearance**—The vertical clearance beneath the Southbound Loop Ramp is as low as 7 feet 4 inches. This is illustrated in Figure 11. The vertical clearance beneath the Northbound Bypass Ramp is as low as 7 feet 1 inch. a 10-foot minimum vertical clearance is required for undercrossings.

Figure 11: Vertical clearance of multi-use pathway beneath northbound bypass ramp is almost 3 feet lower than standard.

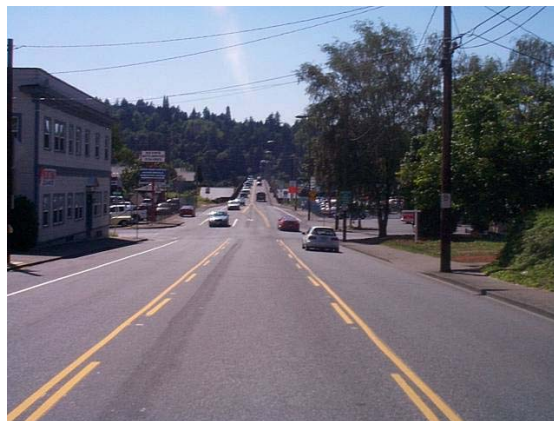
Southeast Tacoma Street runs in an east/west direction between the Sellwood Bridge and the Clackamas County border. The segment of Tacoma Street within the study area is from the eastern terminus of the Sellwood Bridge to southeast 6th Avenue. Tacoma Street is owned and maintained by the City of Portland, and is classified in the City of Portland Transportation System Plan (TSP) as both a District Collector and a Community Main Street. The average daily traffic (ADT) along Tacoma Street between the bridge and 13th Street is 31,000 vehicles/day<sup>4</sup>. Within the study area, Tacoma Street has two lanes (one lane in each direction) with an easterly left-turn lane onto southeast 6th Avenue. There is a sidewalk on the north side of the road. There are no bicycle lanes on Tacoma Street.

Figure 12: SE Tacoma Street immediately east of the Sellwood Bridge has one travel lane in each direction.
